**EMERGENCY SINKHOLE INVESTIGATION
WORK ORDER # 1**

**1400 BLOCK OF SOUTH 14TH STREET
HARRISBURG, PA**

**Prepared for:
City of Harrisburg**

Project Number: 59166

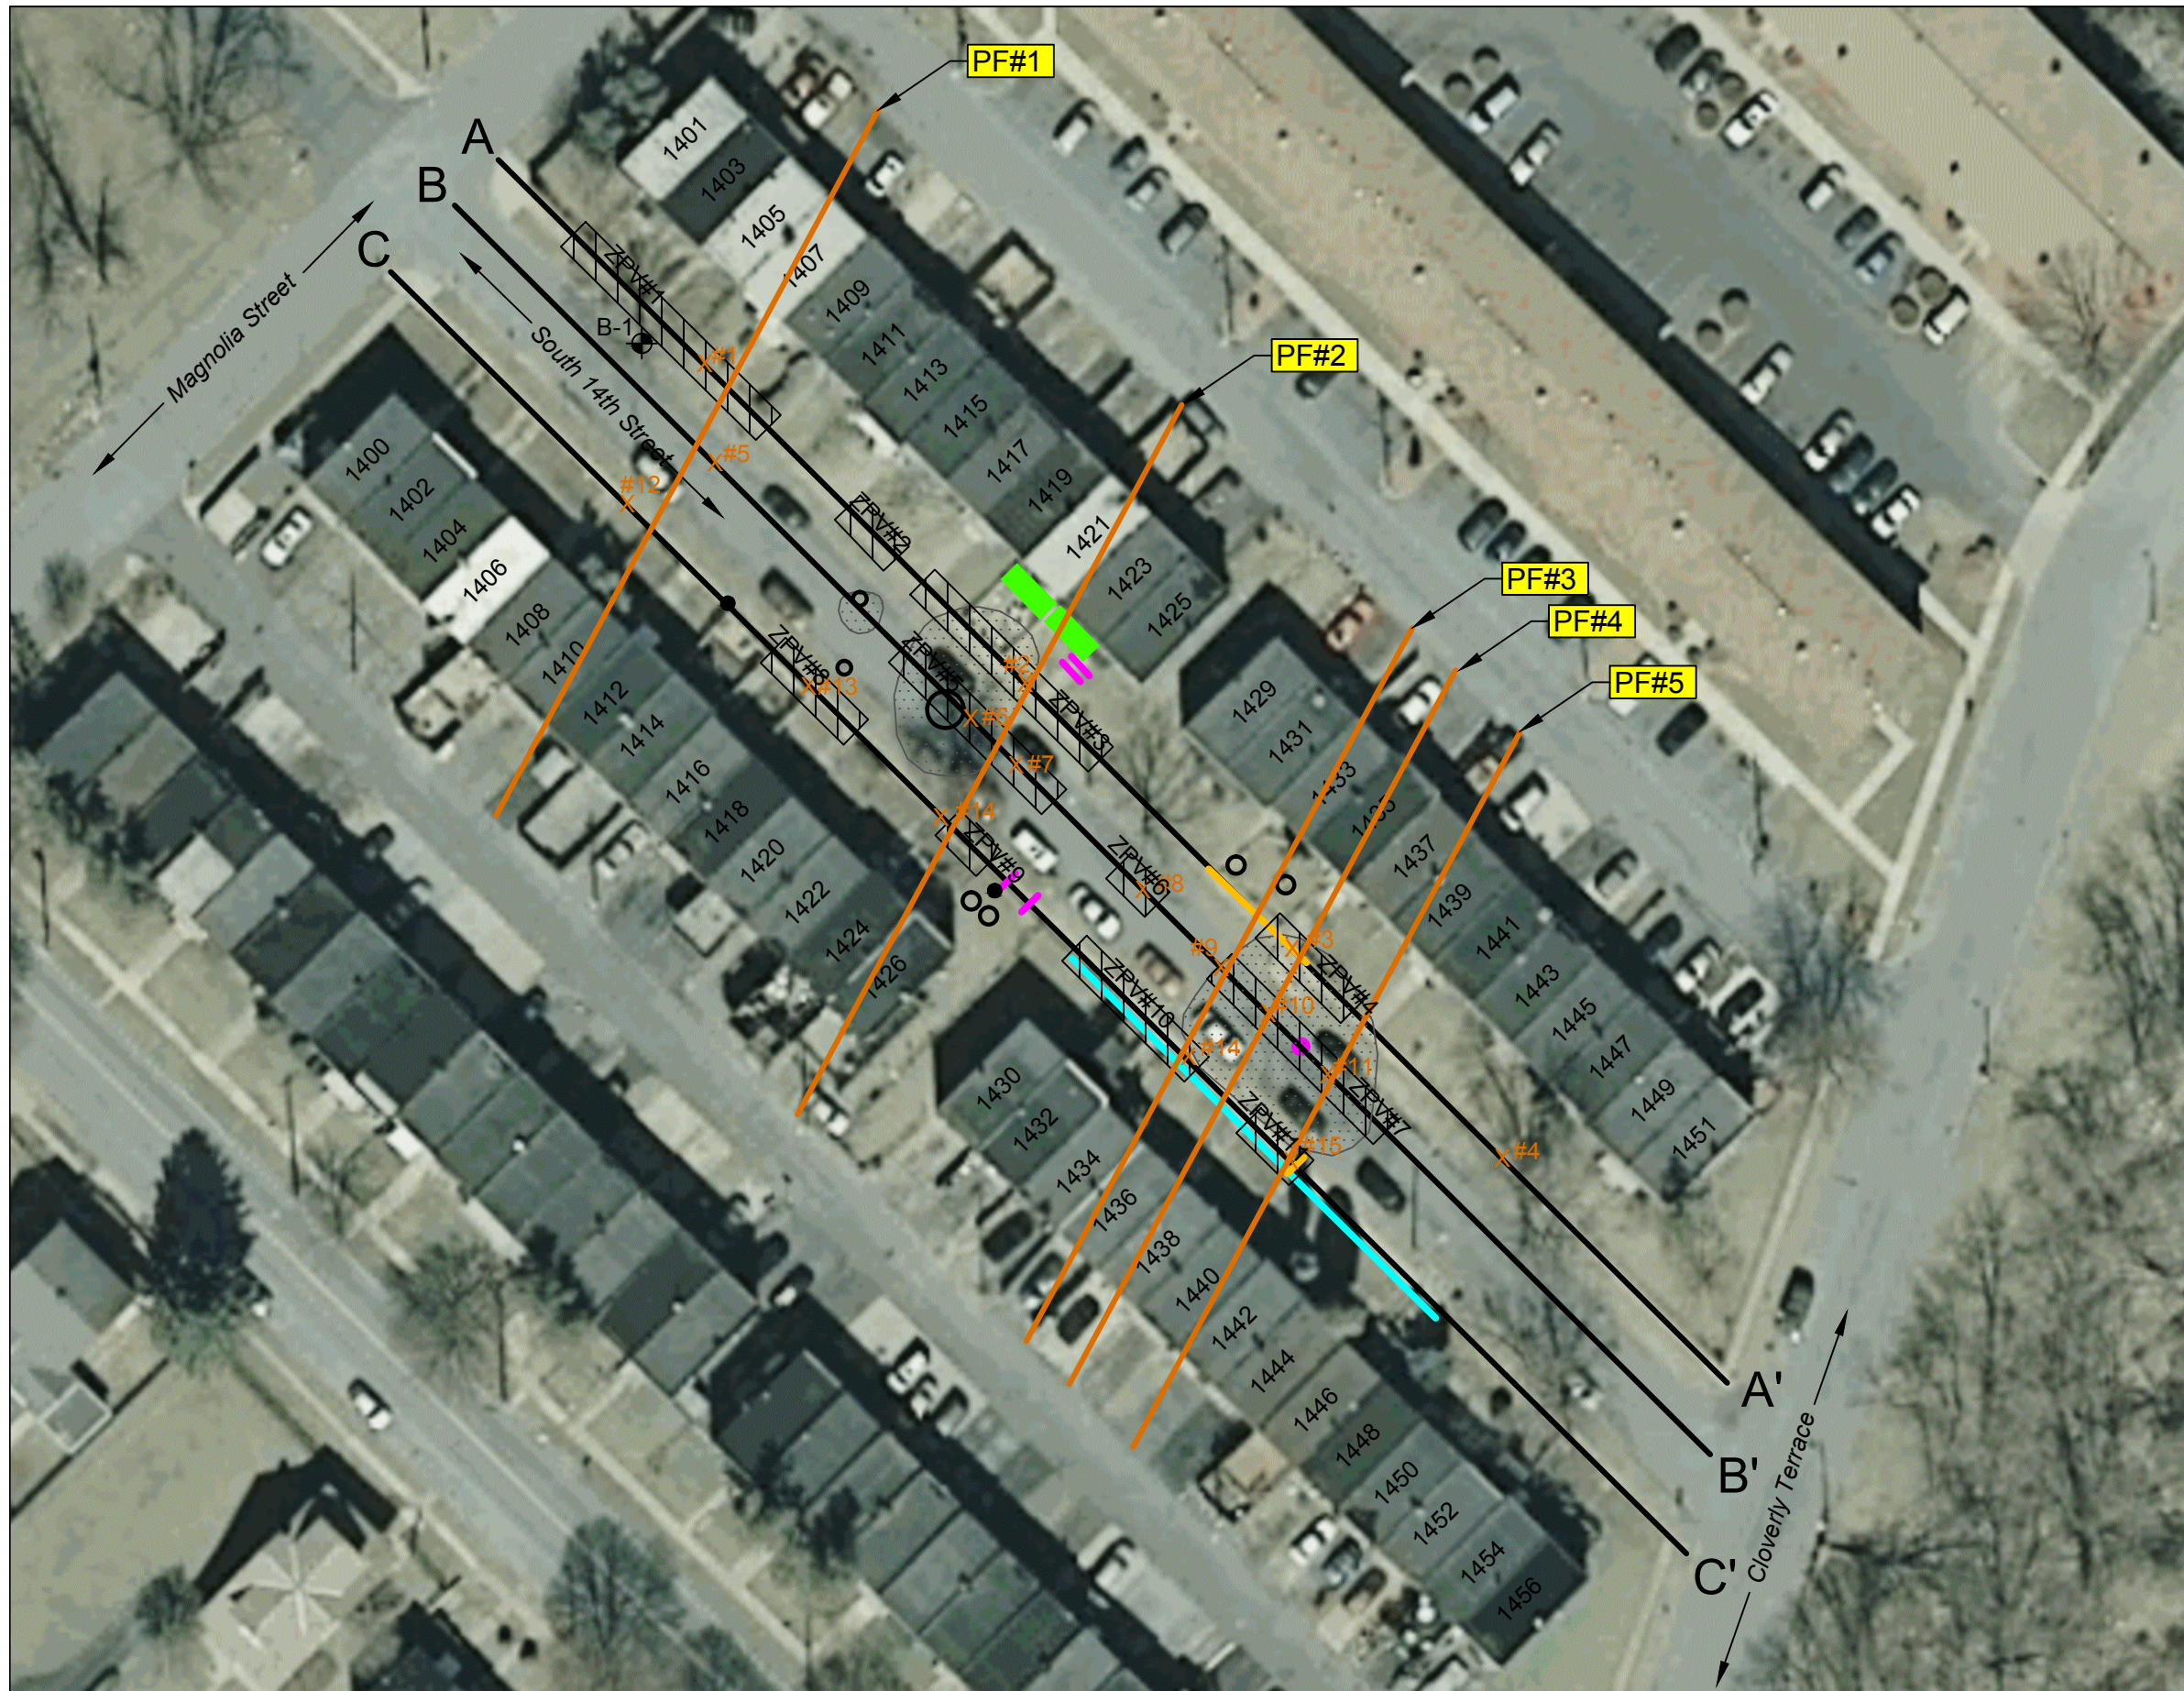
Site Plan
 South 14th Street
 Harrisburg, Pennsylvania

Site features described below are shown on Figure 1, Site Plan. The limits of areas affected by previous sinkhole events are not known with accuracy, but are shown based on conversations with residents, newspaper reports and site observations of apparent repairs.

In March of 2014 a series of sinkholes opened-up concurrent with a water main break in the vicinity of the area between house numbers 1420 and 1422 on the south and 1421 and 1423 on the north. As a result of the sinkholes, nine residential properties were deemed structurally unsafe by the Harrisburg City Code Enforcement Officers. The locations of these properties are shown on Figure 1.

- Newer sidewalk, possibly replaced during the sinkhole repair, is present in front of house numbers 1430 to 1448.
- Sags in the sidewalk are present in front of house numbers 1440, 1435, and 1433.
- Closed depressions are present in the lawns in front of house numbers 1433 and 1435.
- A sinkhole opened up between house numbers 1436 and 1439 during the performance of the MASW survey.

- Several surface depressions were observed in the vicinity of the sinkhole repair area.
- The entrance sidewalk to house numbers 1423 and 1425 was saw-cut during the sinkhole repair. A shallow void is present below the sawcut joint.
- A sinkhole, two closed depressions and a depressed sidewalk slab with void space below the joint is present in front of house numbers 1426.

Fracture-like anomalies, potential fractures, indications of soil piping, and zones of potential voids are located at/near the sinkhole repairs of 2014 and 2007 (see Site History and Observations) and at/near signs of sink activity observed during the MASW survey (e.g., closed depressions, sags in the sidewalk). Fractures are open spaces or gaps in the rock. Fractures that intersect the top of rock represent a pathway for soils to migrate downwards into voids at depth (soil piping). It appears that soil piping into fractures in the bedrock is the probable means of sinkhole activity along South 14th Street. Soil movement is generally triggered by water, and it can be in the form of stormwater or water from a leaky or broken water line (there is no sanitary in South 14th Street).

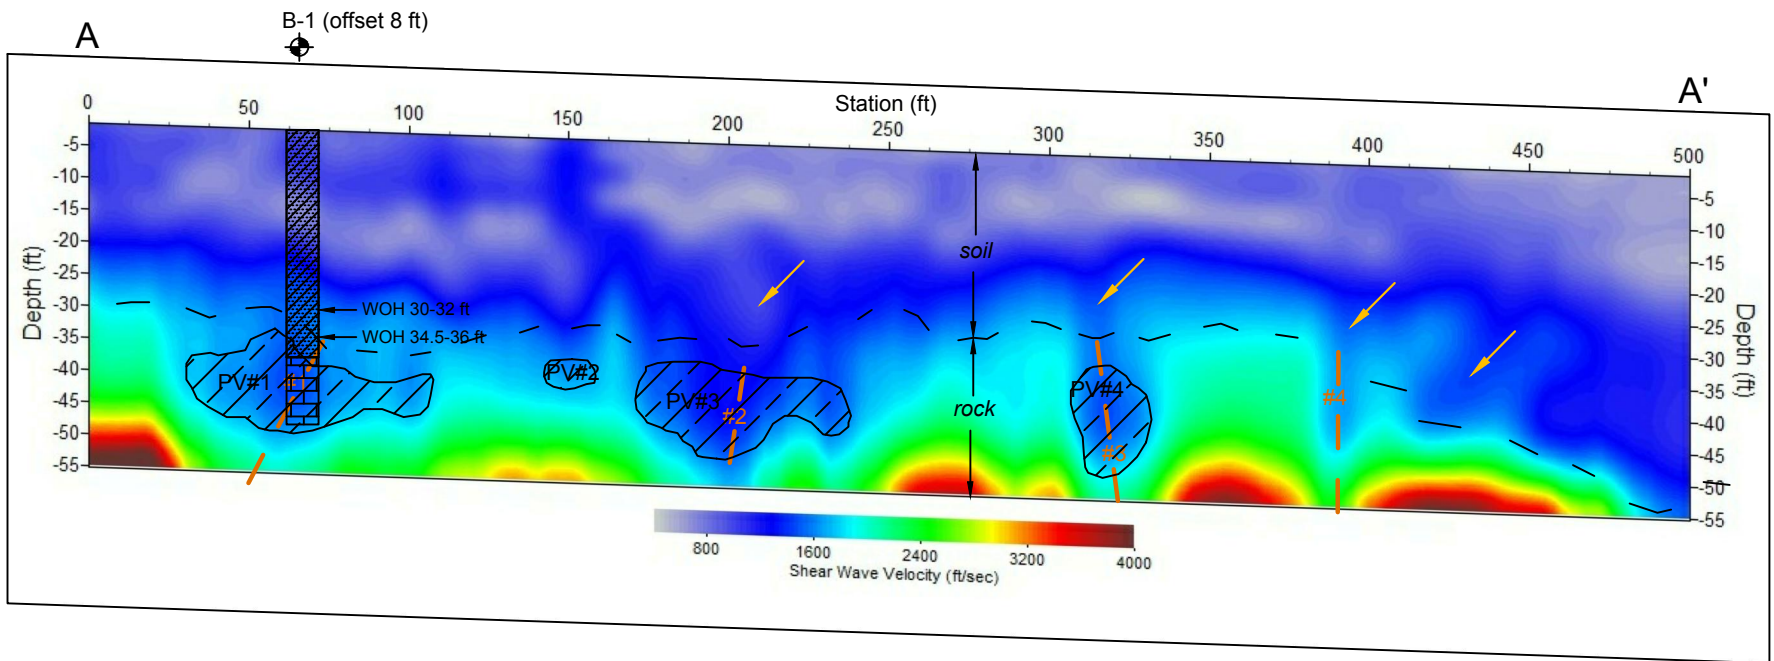
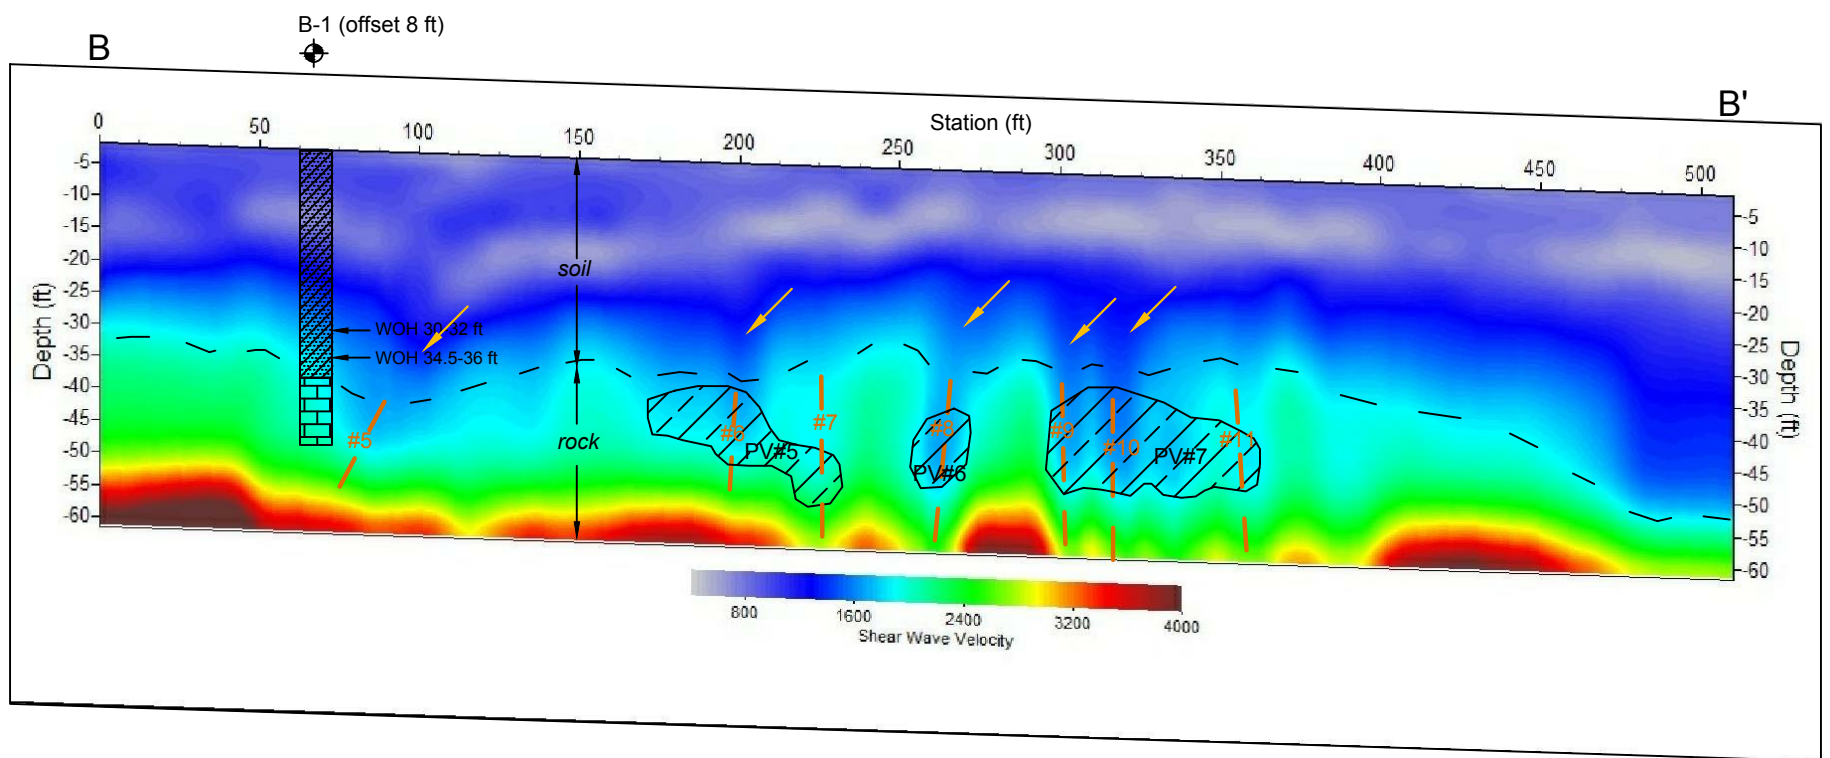
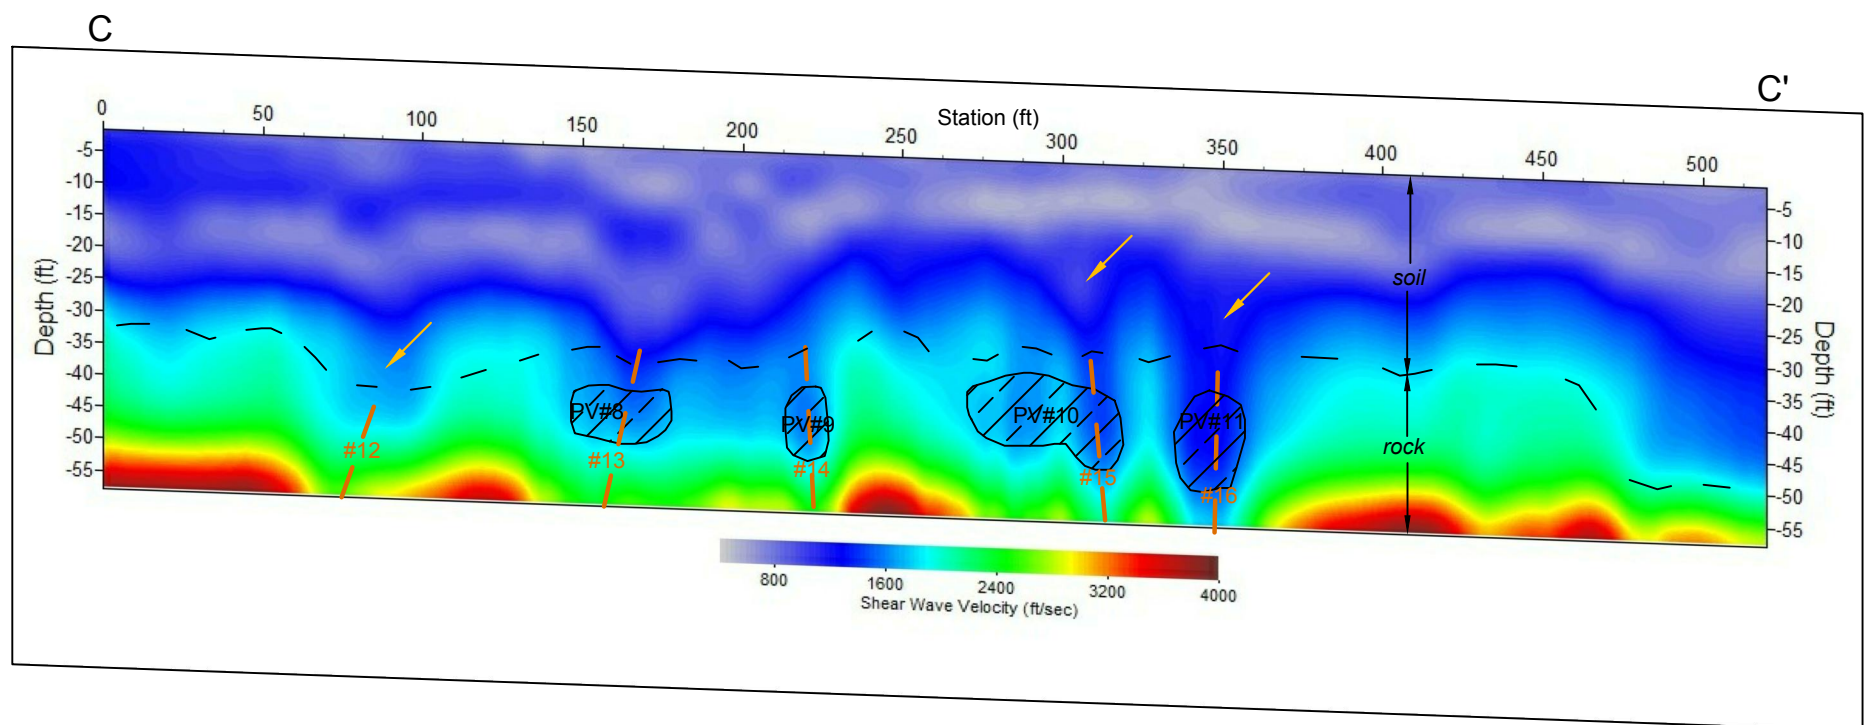
V_s Profiles A-A', B-B', and C-C'
 South 14th Street
 Harrisburg, Pennsylvania

Soils are characterized by shear wave velocities that are nominally 400-600 fps to depths of about 20 feet. At depths greater than 20 feet, velocities increase to almost 1200 fps indicating stiffer soils. This increase in material stiffness is also observed in B-1 which reports higher N-values between 21 and 27 feet.

In general, top of rock is equivalent to a shear wave velocity of approximately 1,200 fps based upon the correlation of B-1 (limestone rock at 38.4 feet) with line B-B'. Top of rock can be less than 1,200 fps where potential fractures and voids are observed within the rock. Rock is described in B-1 as fresh to slightly weathered, intensely bedded, with closely to medium spaced fractures. The description is consistent with the velocities observed on B-B' which are upwards of about 2,400 fps. A similar correlation is not observed on line A-A'. This may be because of the influence of potential voids in the rock. An alternative, although related, explanation is that top of rock along A-A' near B-1 is locally much deeper because a void (solution channel) daylights (intersects) top of rock.

Along most of South 14th Street, top of rock is nominally about 30 to 40 feet deep. Depth to rock increases to upwards of 55 to 60 feet as South 14th Street approaches within 50 to 100 feet of Cloverly Terrace.

Sixteen (16) fracture-like anomalies were observed. They are designated #1 through #16. Four fracture-like anomalies are located on line A-A', seven are located on line B-B', and five are located on line C-C'. They all appear to daylight (intersect) top of rock. Fracture-like anomalies #2, #3, #4, #5, #6, #8, #9, #10, #12, #13, #15 and #16 are associated with narrow, vertical zones of lower shear wave velocities in the overlying clay soils which are indicative of piping. Soil piping or raveling is defined as laterally limited, vertical areas of loose soil often caused by downward vertical movement of the soil. Indications of piping are also observed in B-1 which reports weight of hammer (WOH) at depths of 30 to 32 feet and 34.5 to 36 feet. B-1 is located within approximately 20 feet of fracture-like anomaly #5.

There are five potential fractures based upon a best straight-line fit through a plot of the fracture-like anomalies. They are designated PF#1 through PF#5. The potential fractures trend approximately N28°E.

Eleven zones of potential voids were identified. They are designated PV#1 through PV#11. All but PV#2 are intersected by fracture-like anomalies.

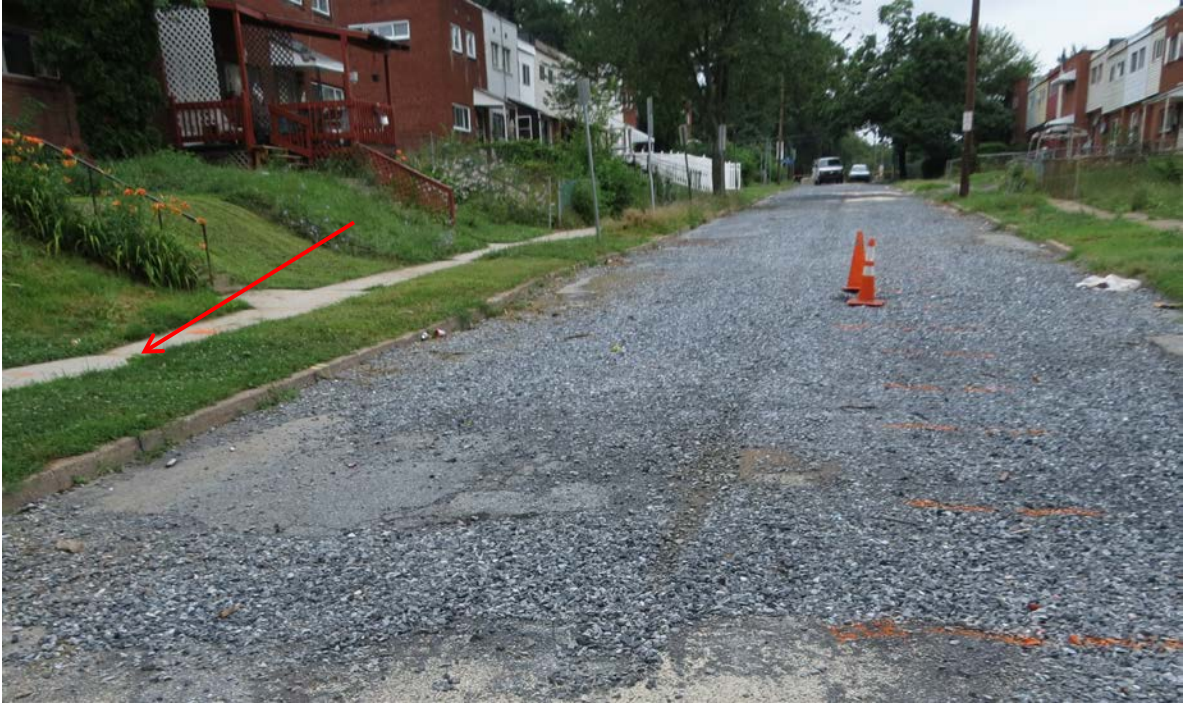
S. 14th Street – Photo 1
Sidewalk Sag on Left in Front of House No. 1440

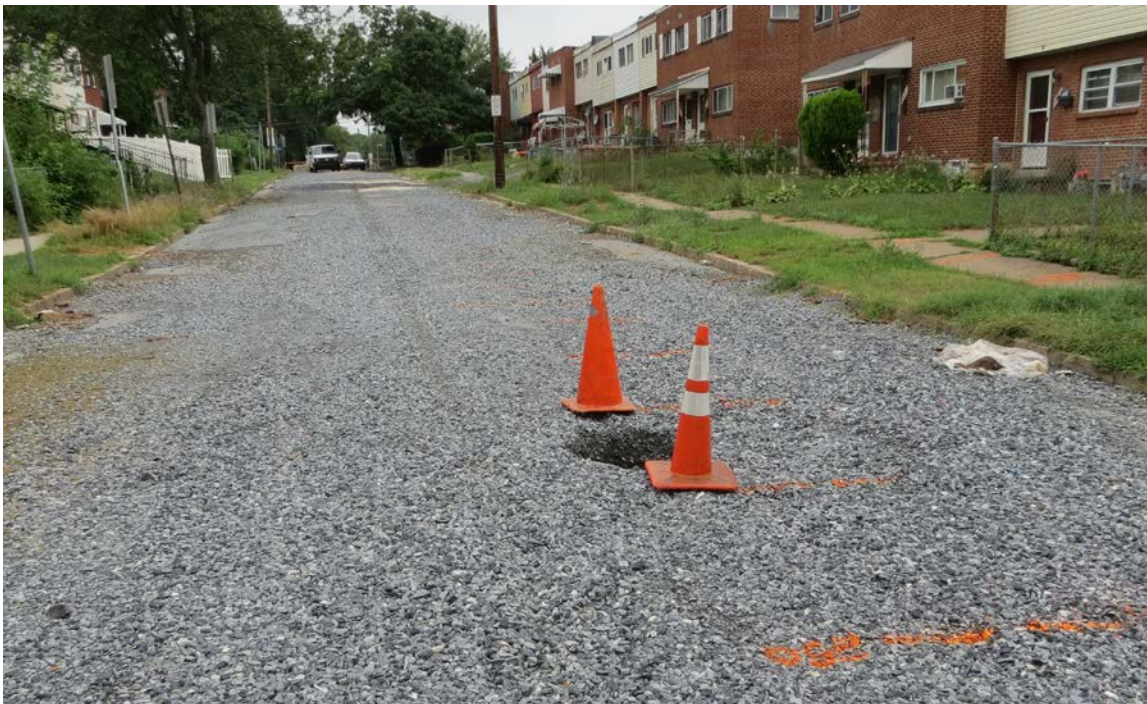
S. 14th Street – 2
Sinkhole Opened During MASW Testing Between House Nos. 1436 and 1439

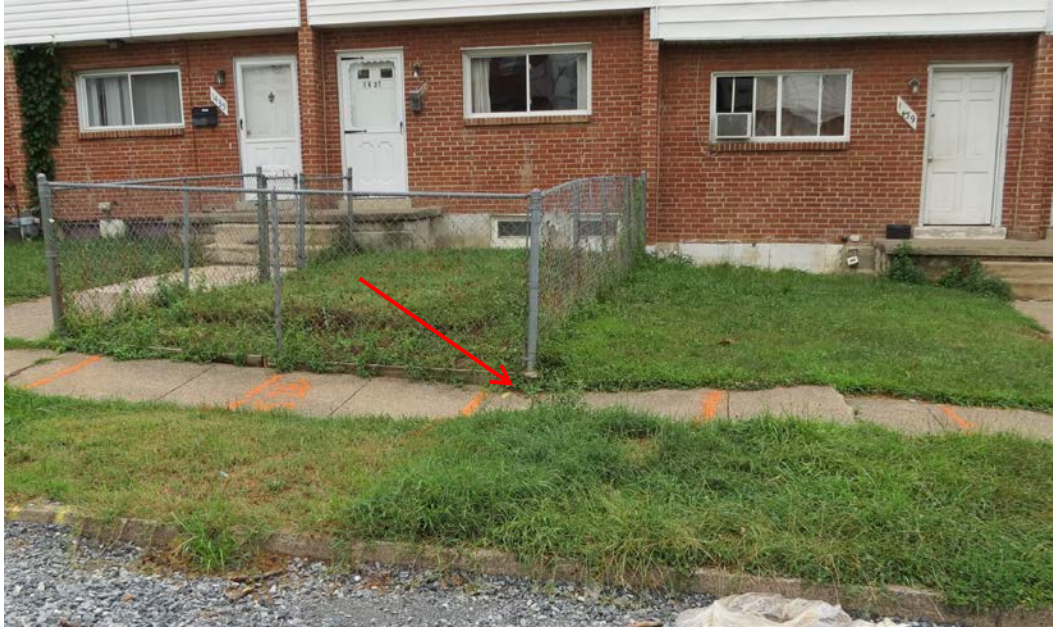
S.14th Street – Photo 3
Sidewalk Sag Between House Nos. 1437 and 1439

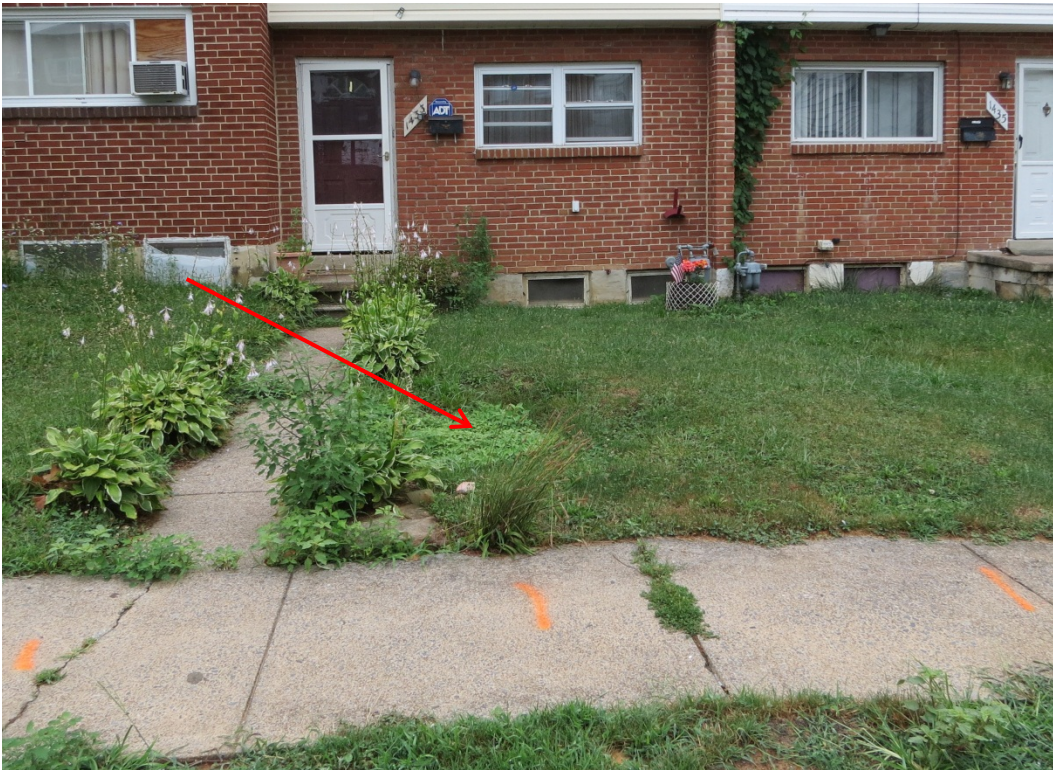
S. 14th Street – Photo 4
Surface Depression in Front of House No. 1433

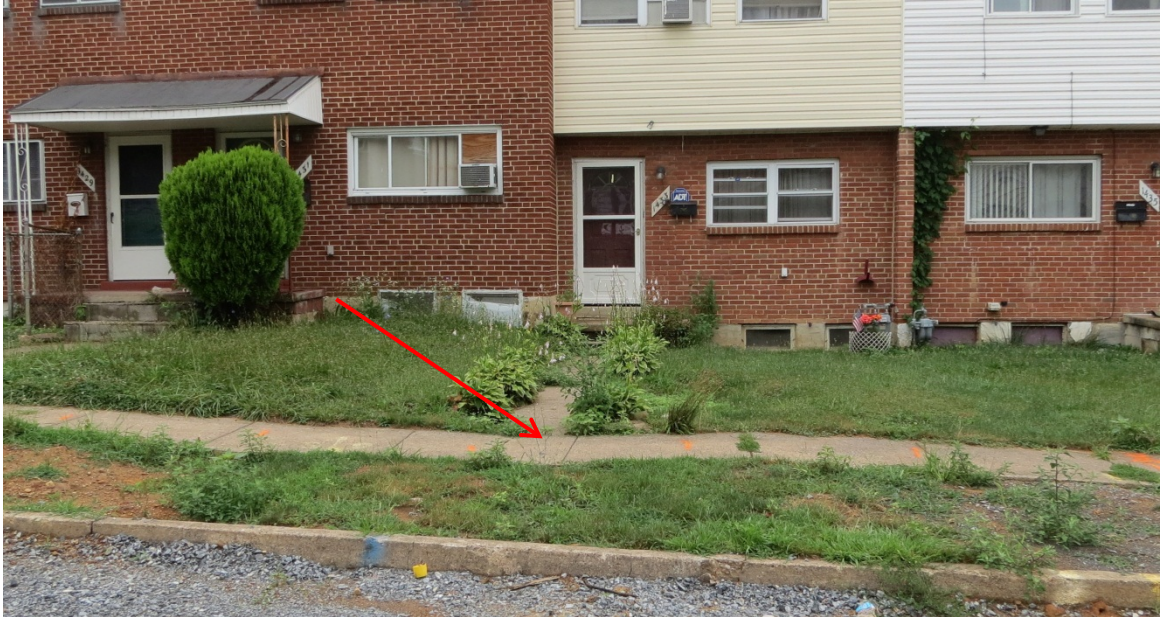
S. 14th Street – Photo 5
Sidewalk Sag in Front of House No. 1433

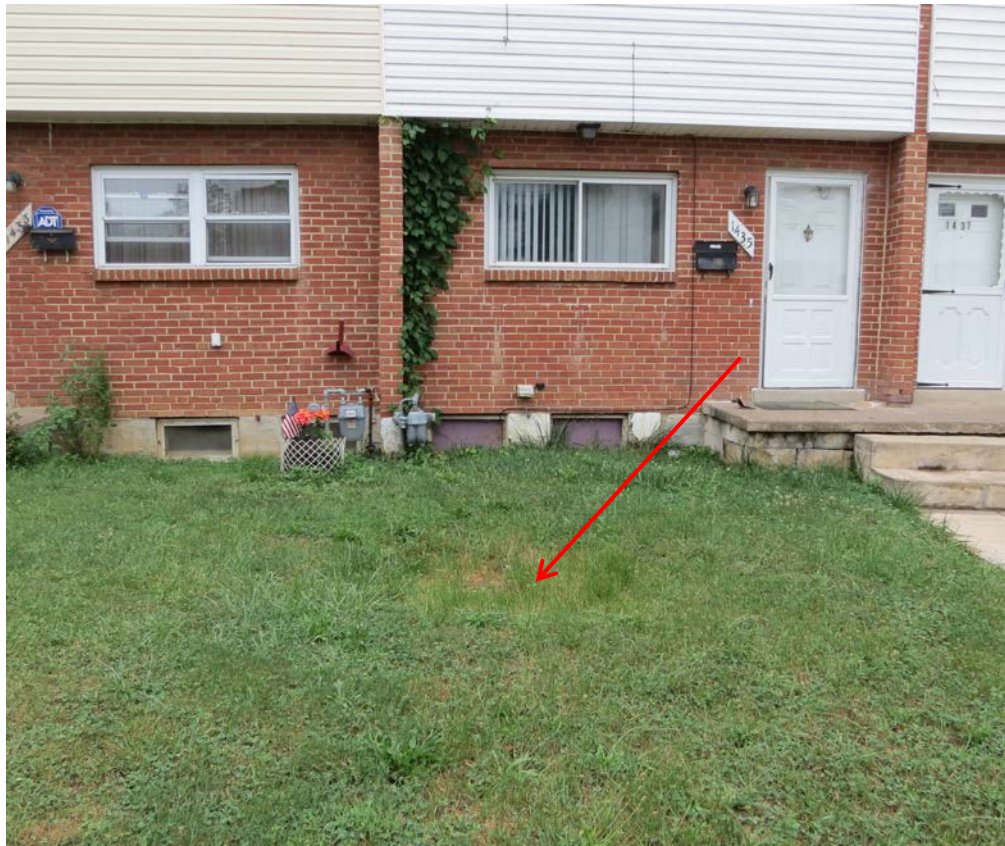
S. 14th Street – Photo 6
Surface Depression in Front of House No. 1435

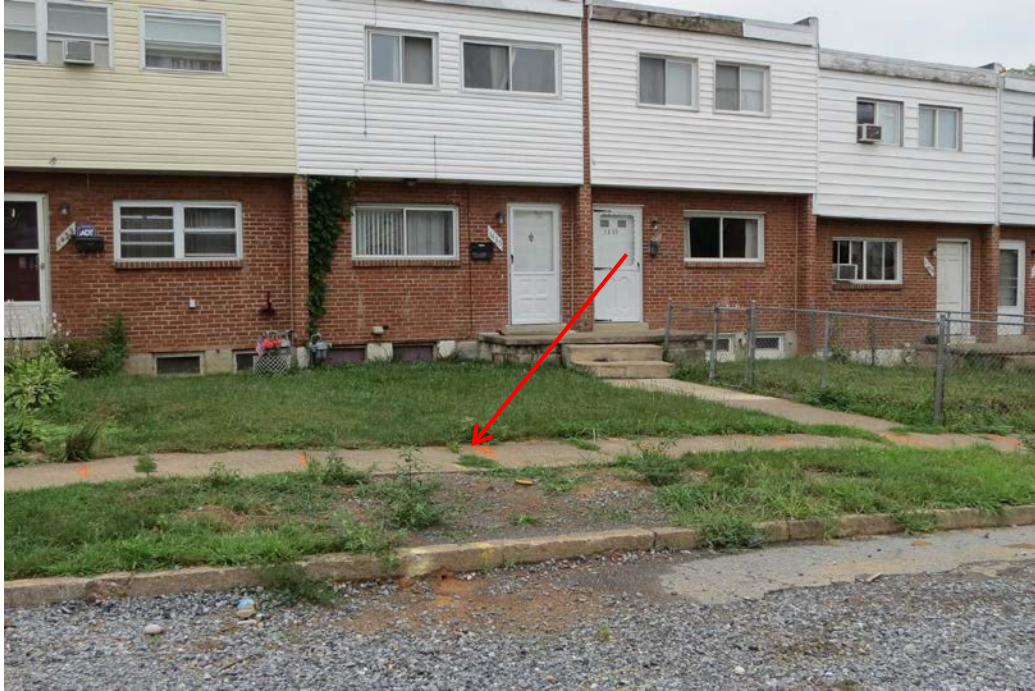
S. 14th Street – Photo 7
Sidewalk Sag in Front of House No. 1435

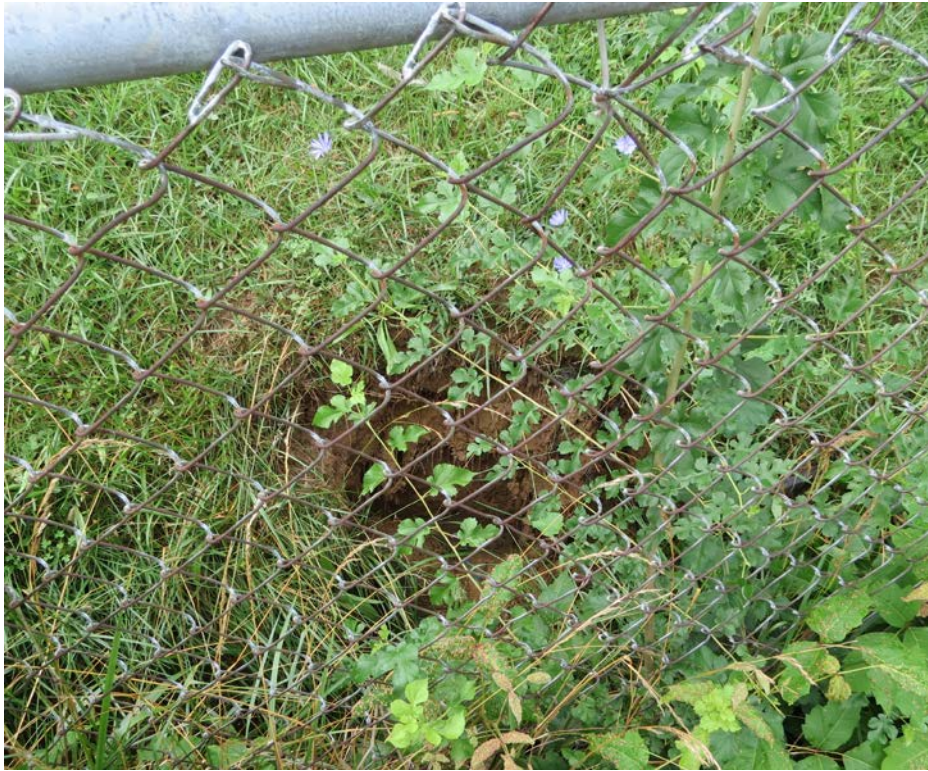
S. 14th Street – Photo 8
Sinkhole in Front of House No. 1426

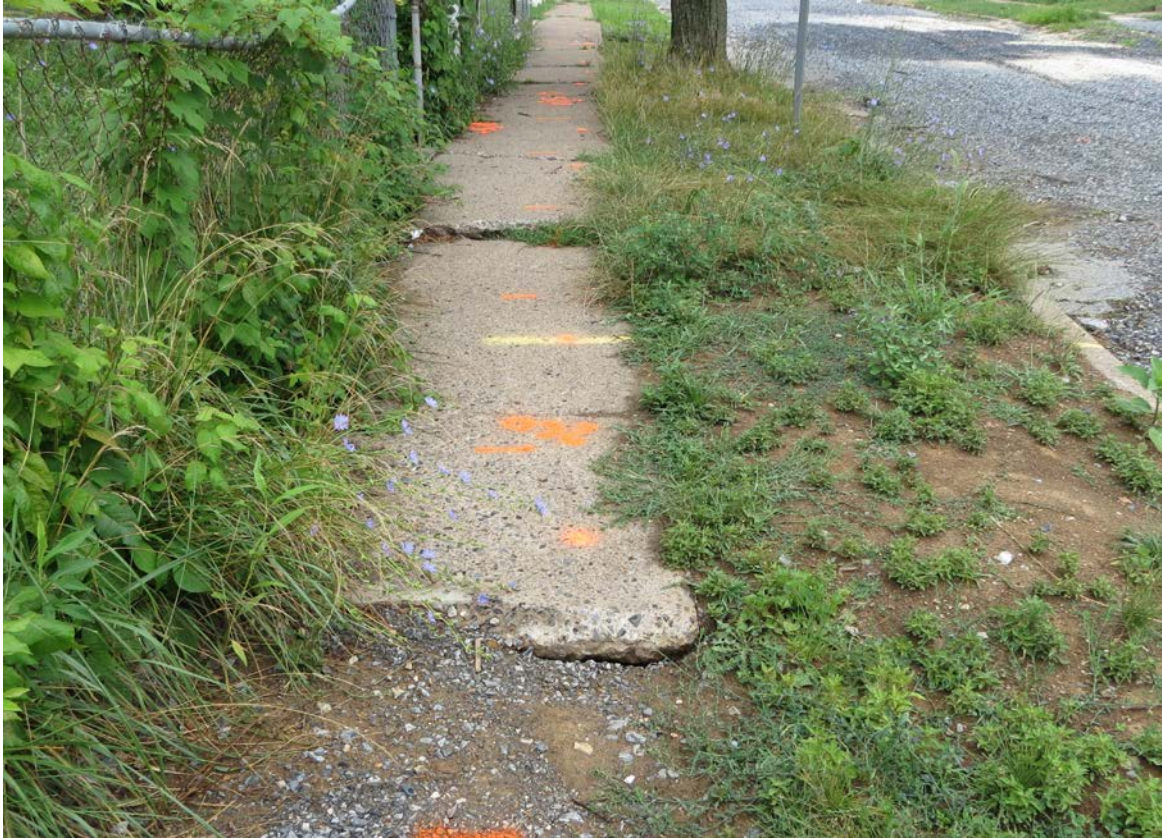
S. 14th Street – Photo 9
Depressed Sidewalk in Front of House No. 1426

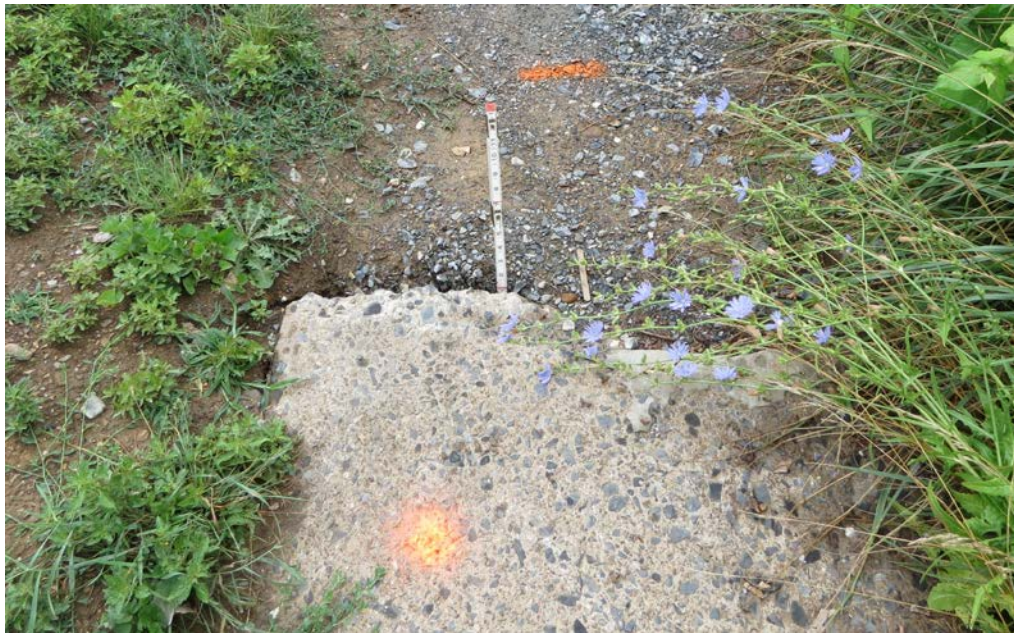
S. 14th Street – Photo 10
Approximately 1'-1" Void Depth Below SW Slab in Front of House No. 1426

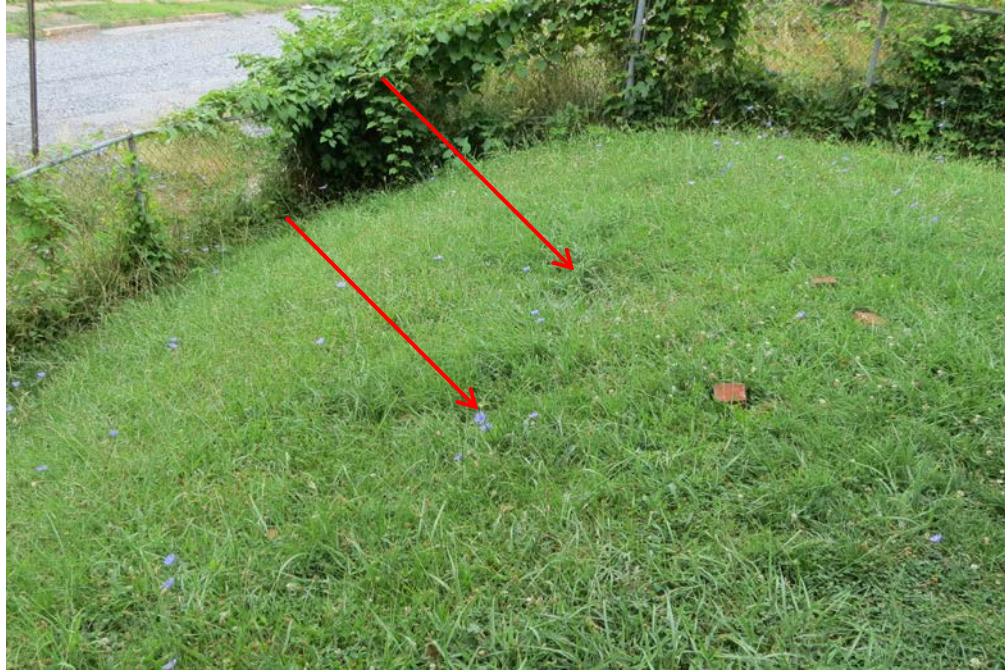
S. 14th Street – Photo 11
Surface Depressions on Top of Slope in Front of House No. 1426

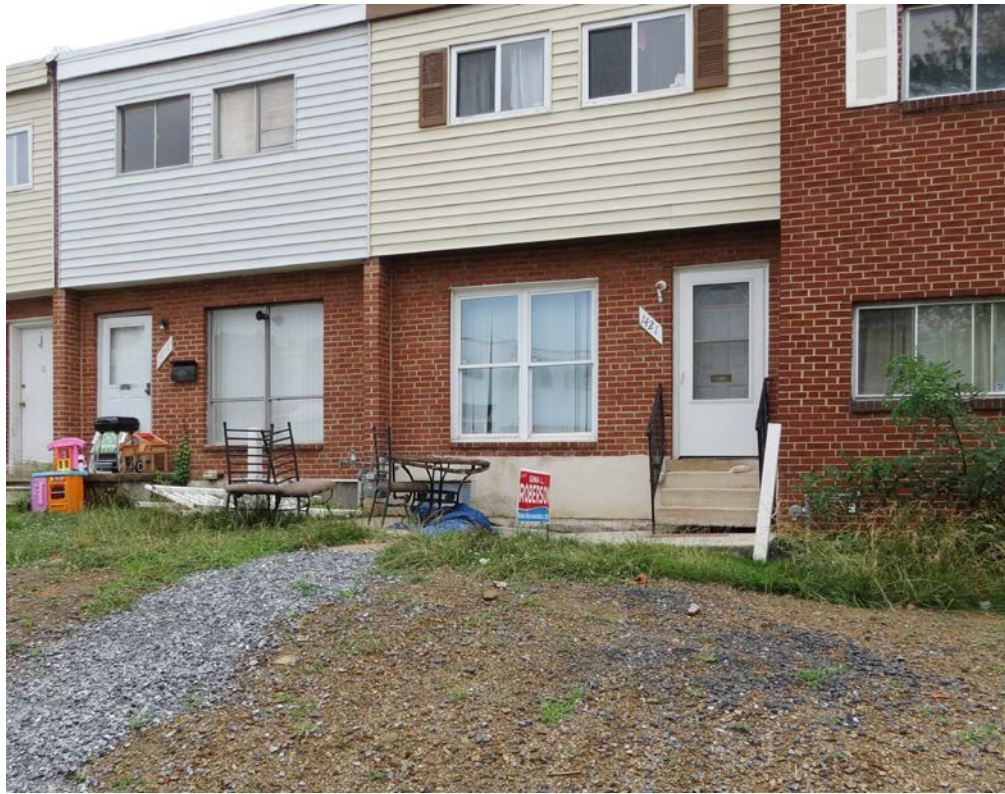
In 1985 structural foundation repairs were reported to have been performed to house number 1421.

S. 14th Street – Photo 12
House No. 1421, Location of 1985 Structural Foundation Repair with Evidence of Recent Subsidence

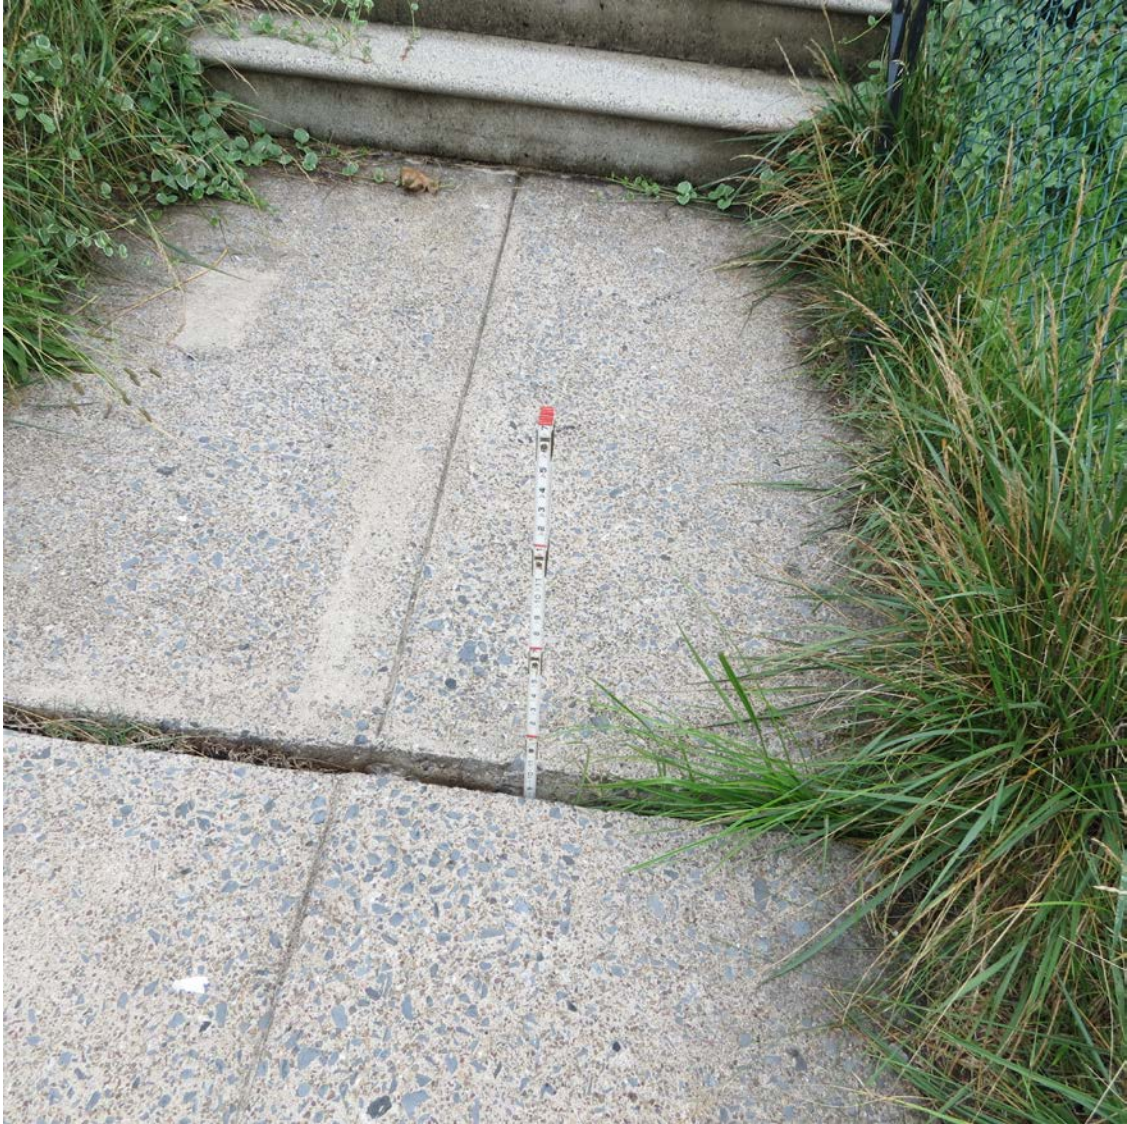
S. 14th Street – Photo 13
Approximate 11" Void Depth Below Entrance Sidewalk at House No. 1423
